# Journal of Human, Earth, and Future

## Evaluation of Geology and Hydrogeology of the Water Leakage in Hammam-Grouz Dam, Algeria

A. Toumi <sup>1\*</sup>, B. Remini <sup>2</sup> <sup>1</sup> *Laboratory of Civil Engineering and Hydraulics (LGCH), University of Guelma, Algeria*<sup>2</sup> *Department of Water Sciences, Faculty of Blida University, Blida 9000, Algeria*

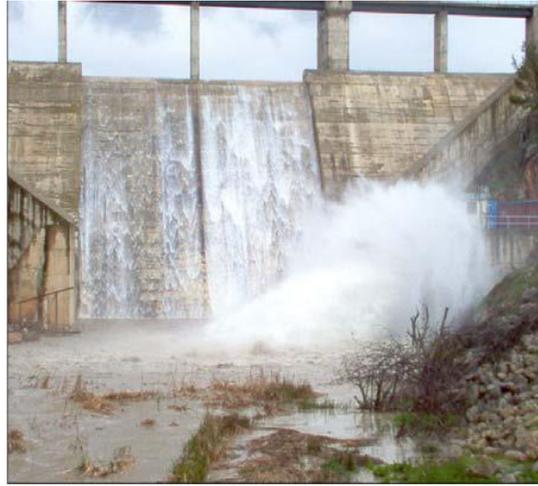
**Figure 5. First water discharge at Hammam Grouz dam in January (2003)**

This spill, which lasted from January 28, 2003 until April 27, 2003, brought the level of water in the lake to a level higher than the normal level of containment (727.00 m) and just at a level of 727, 08 m which puts the supports and the basin of the dam under exceptional pressure [12]. This pressure led to the appearance of twelve (12) resurgences downstream and more precisely on the right bank of Rhumel river (see Figure 6), with a flood of the lower gallery (see Figure 7). Figure 8 represents an approximate diagram of the places of the resurgences generated downstream of the dike.

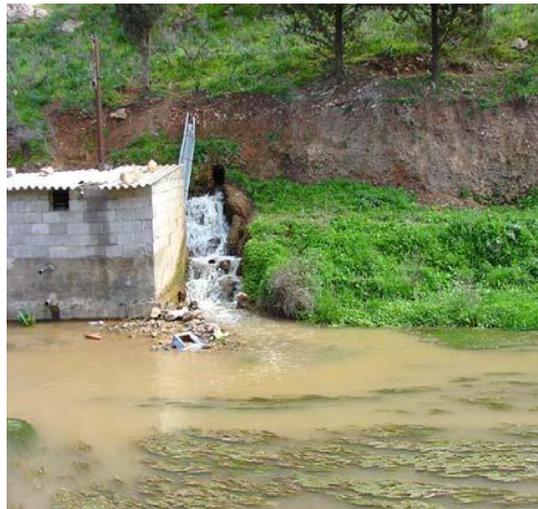
**Figure 6. Appearance of resurgences downstream of the right bank of Hammam Grouz dam**

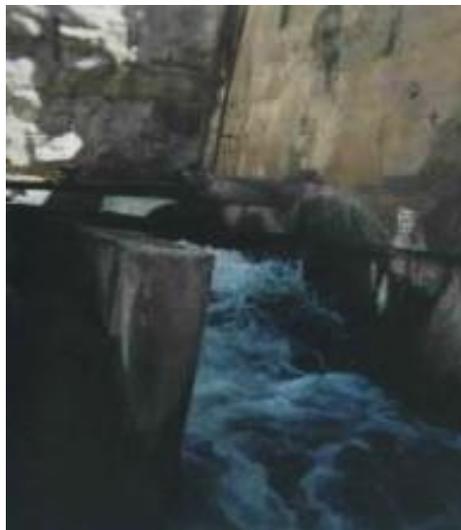
**Figure 7. Flooding of the lower gallery**

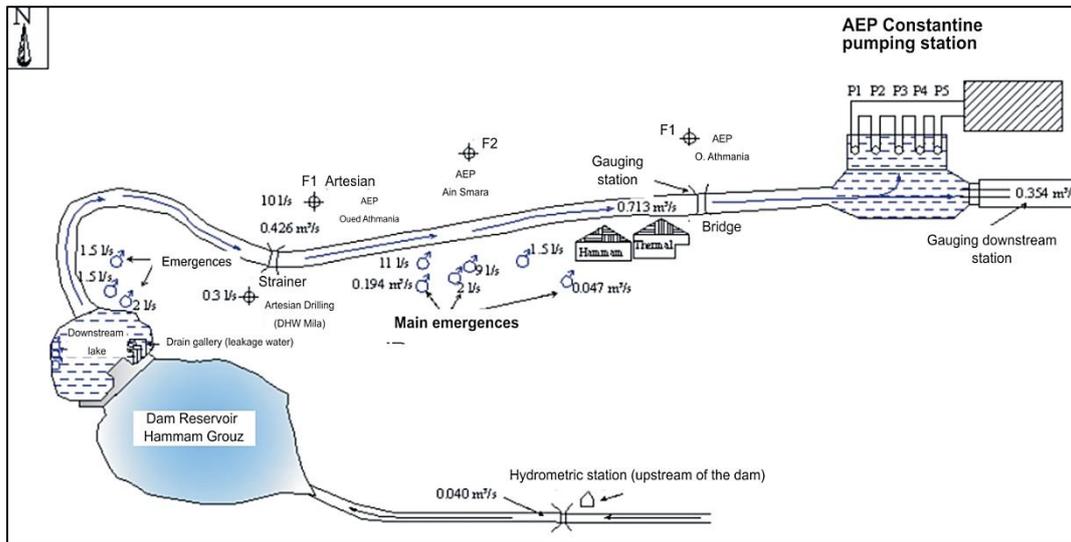
**Figure 8. Rough diagram of the resurgences appeared downstream from Hammam Grouz dam**

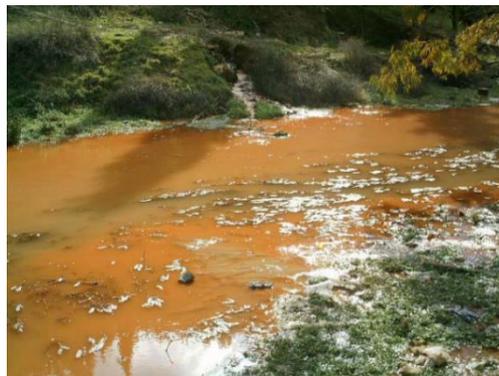
**Figure 9. Reddish leakage water downstream of Hammam Grouz dam photo taken at the right bank**

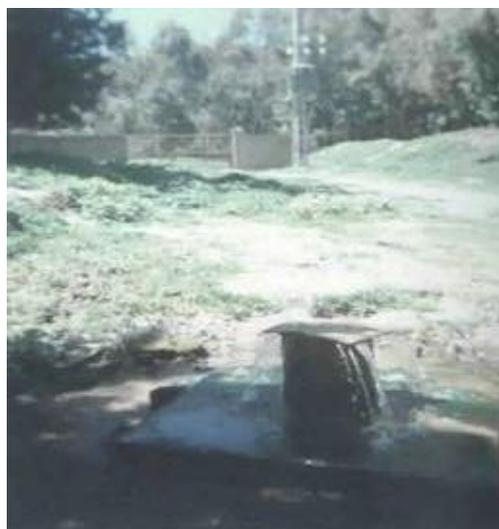
**Figure 10. A pressurized borehole located downstream from the dike of Hammam Grouz dam**

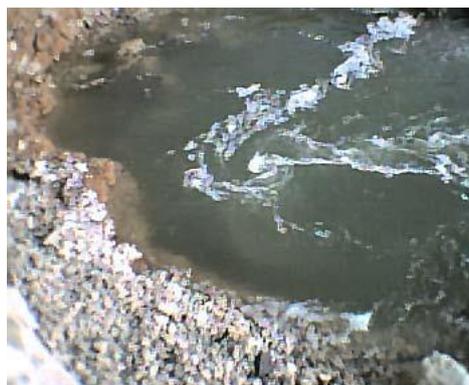
A series of leak flow measurements was carried out from 16 to 20 April 2003, giving a value of the total flow, during these times, of all the resurgences of 1.5 m<sup>3</sup>/s, with a capacity of increase. During this period, a vortex appeared in the basin of the dam. However, its size and location were later detected, after the lowering of the water level in the lake, by divers, it has a diameter of about 1.5 m, at the level of the right bank trough from the reservoir lake. Figure 18 clears the vortex n°1 found on the right flank of the lake.

Figure 18. Appearance of vortex n°1

Foreign experts and engineers from N.A.D.T, during the period from 21 to 23 of October 2003, proposed a methodology for the urgent treatment of vortex leaks No. 1. This methodology is based on the following two points:

- Construct an access road on the rip-rap from the main road to the adjacent lake vortex location allowing access to it as shown in Figure 19.
- Construct a platform around the vortex to the 723 m level of 100 m long and store rip-rap materials, (gravel, sand and clay).

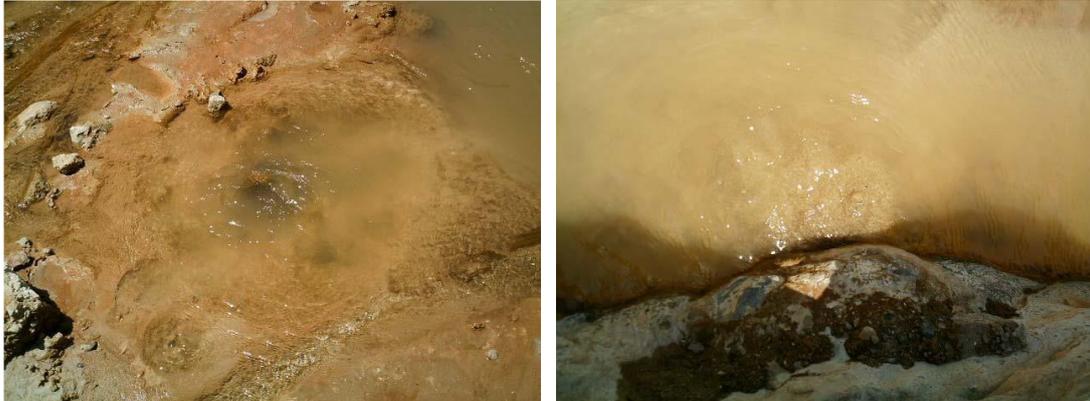
During the first four months of 2005 and after very heavy rainfall (snow and rain), the capacity of the dam increased in a very remarkable way, from 2.86 Hm<sup>3</sup> in December 2004 to 9.24 Hm<sup>3</sup> in January 2005. This increase to continue until the month of May of the year 2005 reaching a capacity of 40.10 Hm<sup>3</sup>. This result has led to a resurgence of sand at some of the resurgences downstream of the dike due to the increase in hydrostatic pressure created by the rise of the water level in the lake. Figure 22 illustrates the gushing of the sand.

Figure 22. Sand downstream of the dam

This appearance is due to a migration of earthy particles either clay or karst fissure joints what is called the Renard phenomenon. However, it is confirmed that this sand contains a percentage of that filled in the first sinkhole and another of the filter layers put in the second sinkhole is not yet guaranteed. This sand spout testifies that the first consolidation treatment realized during the construction of the dike, was modified naturally (under the effect of the underground infiltrations) or it was not perfect. This spurt of sand will also lead to an enlargement of the sections of the preferential paths of the water. Consequently, we witness an increase in the volume of water lost. However, the problem that arises is the influence of this escape of the sand when the level of the lake would be maintained, a sufficient time, at a value very close to that of the normal level of the reservoir.

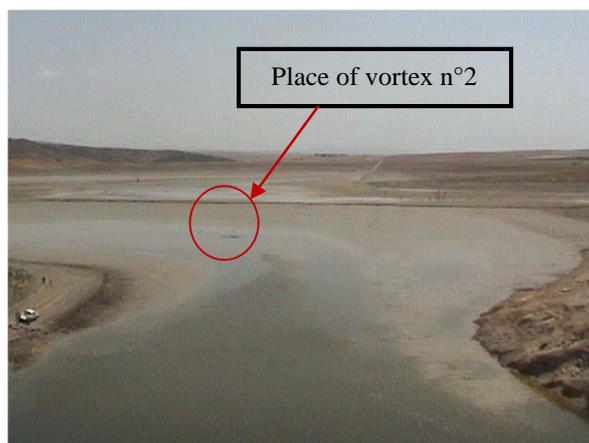
In November 2007, following the remarkable narrowing of the lake of the reservoir, a second larger vortex appears at the right bank of the Hammam Grouz reservoir and consists of two openings very close. Figure 23 elucidates the location of the new vortex in the lake.

Figure 23. Appearance and location of the vortex n°2 in the lake of Hammam Grouz dam

Following this appearance, we can think of the reactivation of the area of the old vortex where the thickness of the alluvial cover does not exceed a few meters. As a result, the clay carpet collapsed at the opening of the old vortex and above the new one. The Figure 24 shows the Diagram of a longitudinal section of the vortex 02 before its sealing.

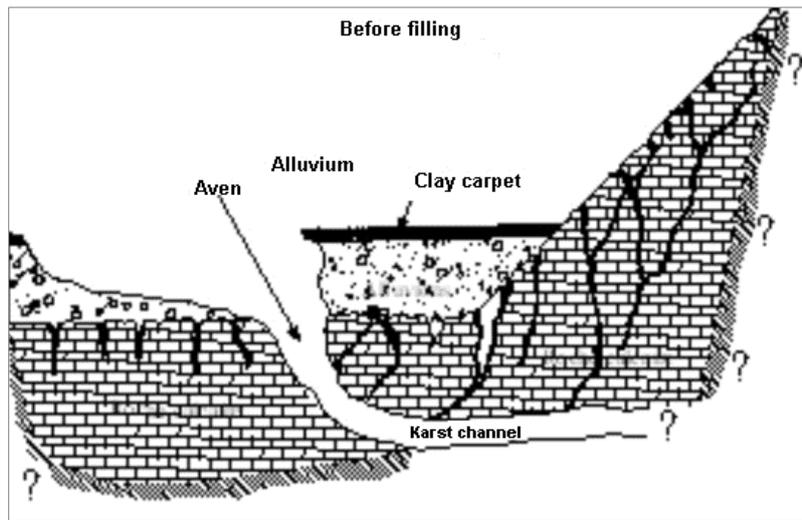
Figure 24. Diagram of a longitudinal section of the vortex n°2 before its sealing

Water losses from the reservoir through the right flank have increased significantly in the direction of downstream resurgences. This last problem caused the emptying of the reservoir, and since, the capacity is of the order of 0.002 Hm<sup>3</sup>, whereas during the first three months of the year 2008 (January, February and March), the restraint is practically at dry. This situation has led the departments concerned, to really think about solving the problem was regenerating at this place.
