# Journal of Human, Earth, and Future

## Evaluation of Geology and Hydrogeology of the Water Leakage in Hammam-Grouz Dam, Algeria

A. Toumi <sup>1\*</sup>, B. Remini <sup>2</sup> <sup>1</sup> *Laboratory of Civil Engineering and Hydraulics (LGCH), University of Guelma, Algeria*<sup>2</sup> *Department of Water Sciences, Faculty of Blida University, Blida 9000, Algeria*

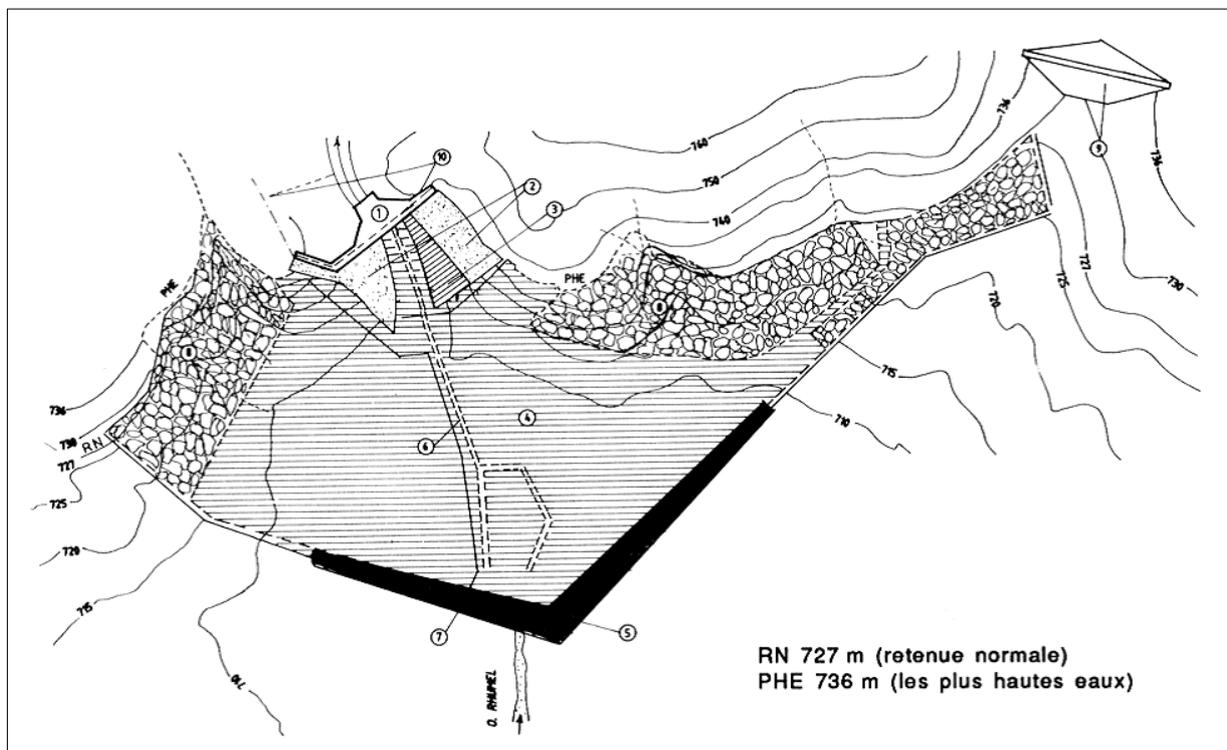
The two so-called sinkholes have undergone a particular treatment, one being filled with sand and then with mass concrete, the other one was filled with several filtering layers. But these questions also arise: could this treatment not be modified? Would this lead to the reappearance of the old sinkholes? Consequently, this may allow major leaks to the underlying limestone and jeopardize the safety and operation of the work and its annexes. Figure 11 shows the sealing work done during the construction of the Hammam-Grouz dam. The impermeable carpet is installed upstream of the Hammam Grouz dam, a clay portion covering the limestone outcrops and permeable alluvium, the other shotcrete and concrete-slabs surrounding the flanks. It is designed to minimize water loss from the bowl by capping the water circulation corridors in the underlying foundations. The waterproofing actions carried out during the construction of the dike to stop the escape of water from the lake are not perfect. Indeed, during the first pressurization of the geological layers, giant water leaks were observed downstream of the dike and the waters of some resurgences have a reddish color (see Figure 9). It gives the impression that there is a dissolution of the red clay used either on the clay carpet or on the filling of sinkholes and siphons.

**Figure 11. Diagram of the waterproofing work carried out during the construction of the dike of Hammam Grouz dam**

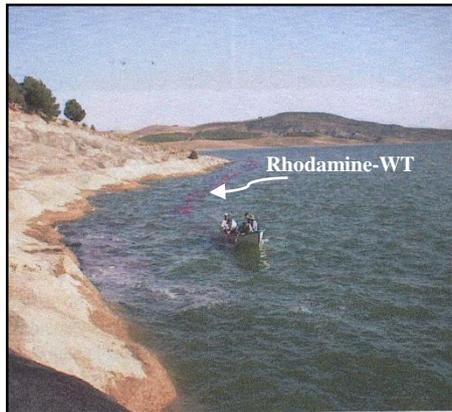
The first findings, on the location of the resurgence sites, claim that most of the spurts downstream of the dike have appeared at the bottom foot of the cliff on the right bank, which gives an idea that this shore is the more vulnerable to leakage of water from the dam lake. However, approval confirmation that the waters of these resurgences have no other origin must be justified by the application of a technique based on tracers. These findings led the CRNA researchers to perform a preliminary detection by tracing with Rhodamine-WT at the lake, on the right flank. For this purpose, a volume of four liters of Rhodamine was injected on the right side of the lake, as shown in figure 12.

**Figure 12. Tracing with Rhodamine – WT at the lake of Hammam Grouz dam**

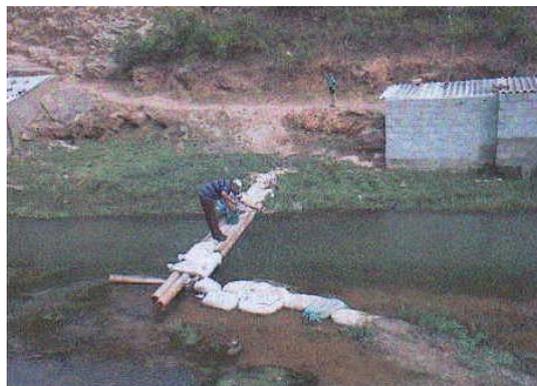
Two automatic samplers were placed, one at the resurgence 01 downstream, near the drainage gallery and the other a little further downstream, next to a platform (resurgence 02) with a step of time of 45 minutes (Figure 13).

**Figure 13. Automatic sampler at resurgence number two located downstream of Hammam Grouz dam**

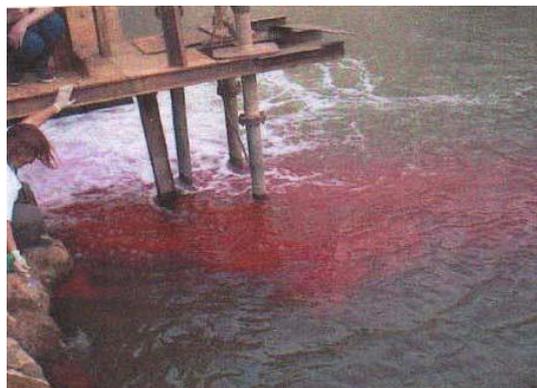
The Rhodamine signal downstream of the dam (Figure 14) confirms the hypothesis that the leaks at the level of the resurgences come from the reservoir and not from the aquifers of the region.

**Figure 14. Rhodamine response downstream from the dike of Hammam Grouz dam**

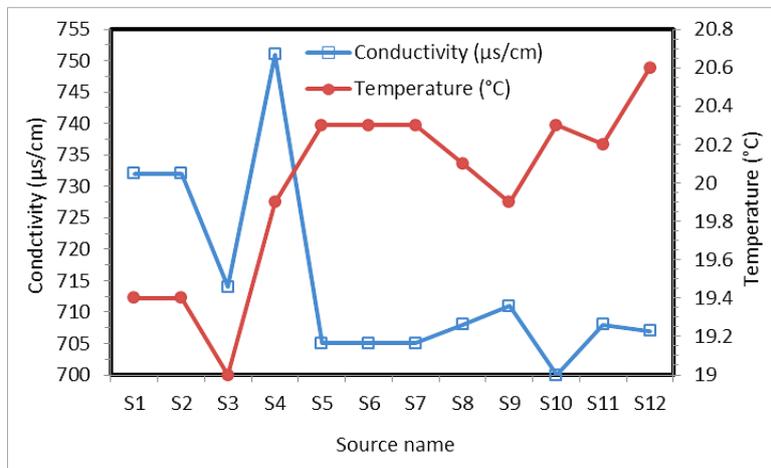
- On June 29, 2003, conductivity and temperature measurements were carried out at all the resurgences located downstream of the dike and the results show conductivity values between 705 and 751  $\mu\text{s/cm}$  and temperature that oscillate between 19 at 20.3  $^{\circ}\text{C}$  (Table 1 and Figure 15).

**Figure 15. Fluctuation in conductivity and temperature at various resurgences located downstream from the dike of Hammam Grouz dam**

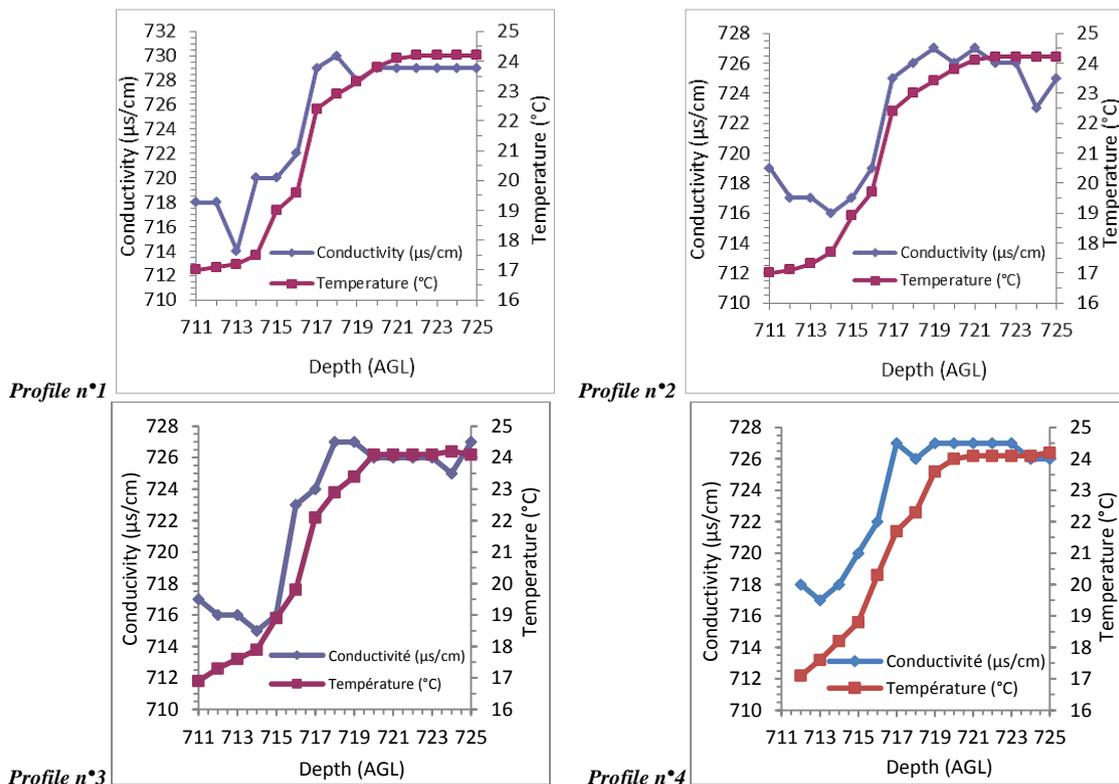
**Figure 16. Variation of couple representing the conductivity and the temperature as a function of the water depth at the different profiles**

The four profiles illustrated at figure 16 make it possible to locate the infiltration zone between the depths 714 and 715 m. Indeed, the remarkable difference of the values of temperature and conductivity becomes significant from the 715 m level and continues up to the 714 m level. The first profile is recorded to have the largest temperature difference between the levels 715 m and 714 m, due to its position very close to the vortex.

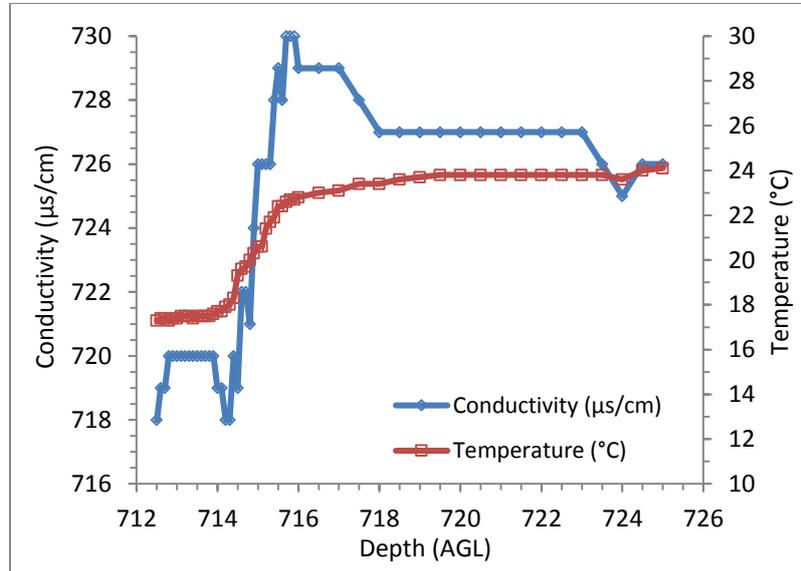
Figure 17. Fluctuation in temperature and conductivity at profile n°1

This representation makes it possible to disclose the levels of water leaks in a range between 714.6 and 714 m. The decrease in temperature by a value equal to 1.3°C for a depth of 0.5 m between 714.5 and 715 m of levels, can only be explained by a mixture of water due to an additional supply from an annex system which exults at the level of reservoir at this depth.

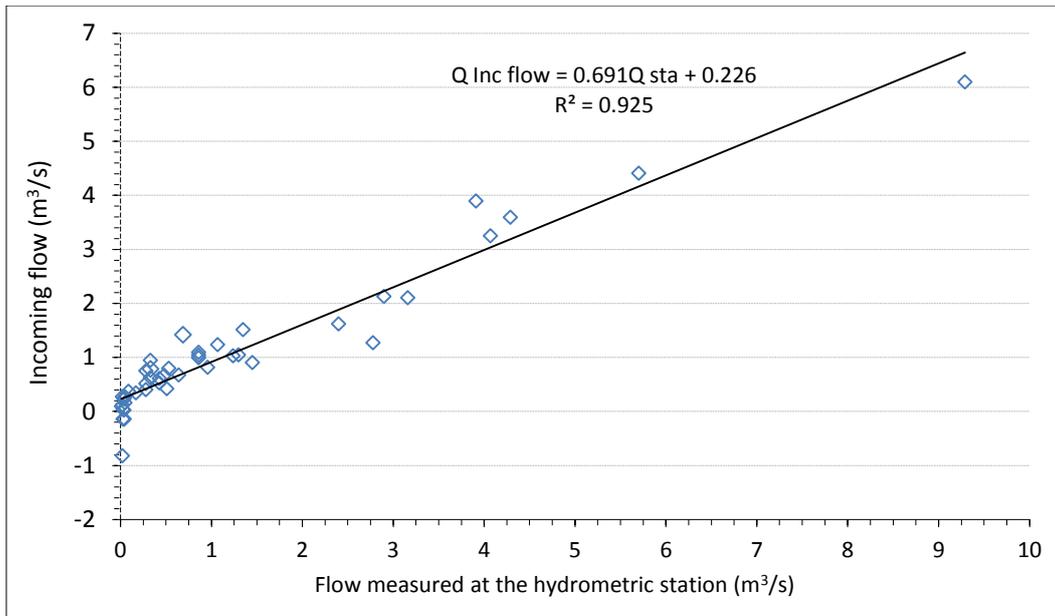
Figure 33. Variation of the real incoming flow in the bowl as a function of the flow recorded at the hydrometric station

It should be noted that a percentage of 7.5 of the variance is not represented by this correlation, which proves that it is not only the flow of the tributary which passes through the hydrometric station which feeds the basin of the dam. Negative inflows have been observed, which indicates that there is a decrease in the level of the water level in the basin of the dam that is to say that the quantity of water leaving the basin exceeds that entering.

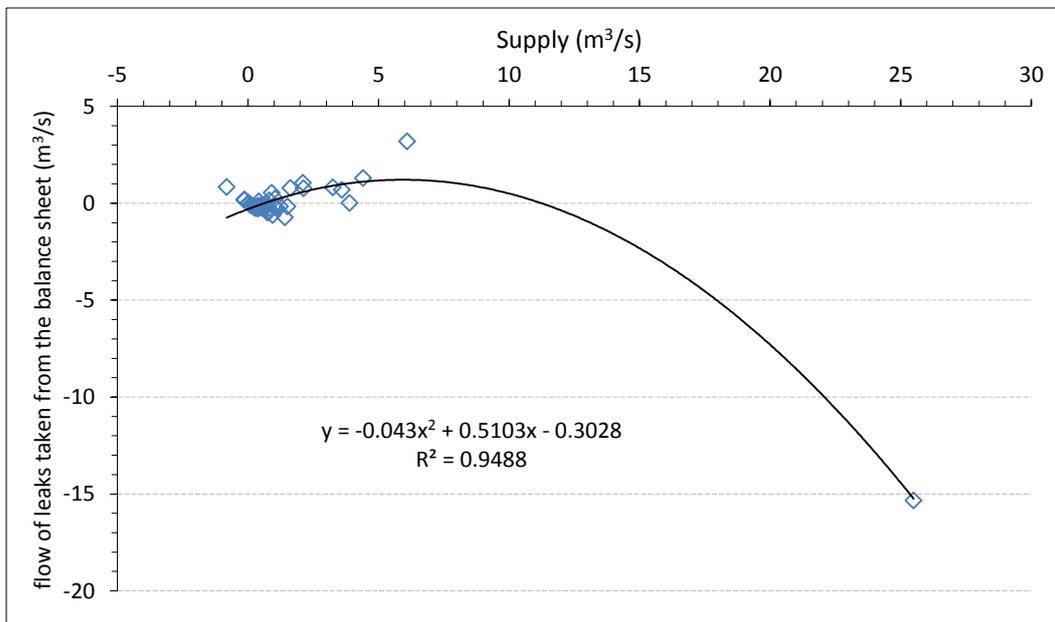
Figure 34. Variation in the leakage rate deduced from the hydraulic balance as a function of the entering flow of Hammam Grouz dam, Algeria

Negative flow values show that the inflow per tributary deducted from the daily water balance of the dam is greater than the inflow recorded at the hydrometric station.

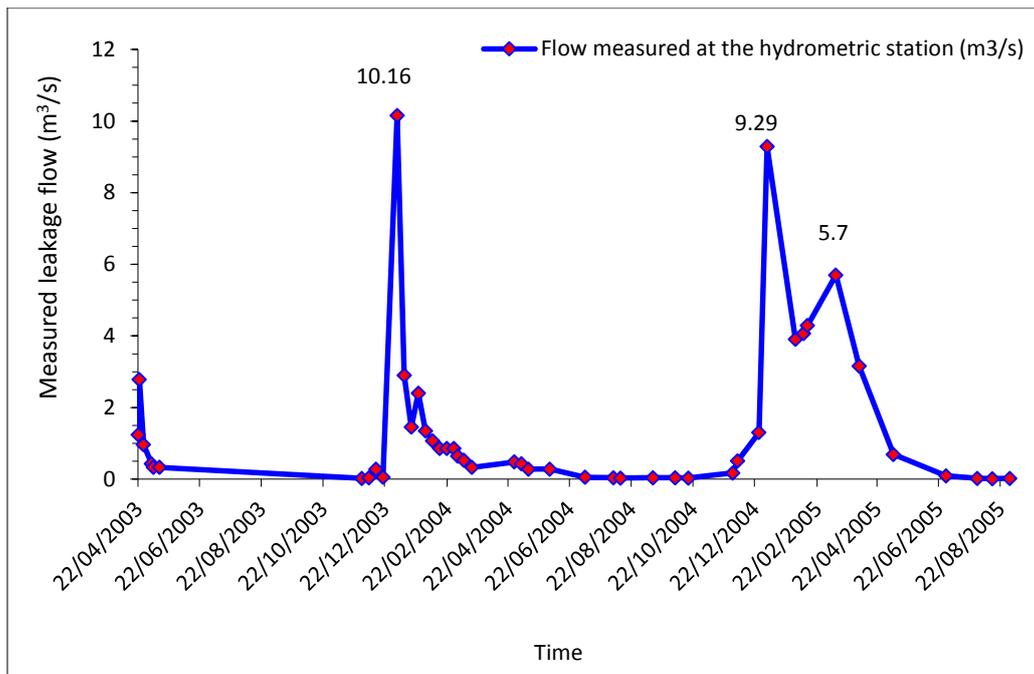
Figure 35. Variation over the time of the flow rate of water leaks measured downstream of Hammam Grouz dam

This representation makes it possible to extract the maximum peak leakage values recorded on 23/04/2003, 14/02/2004 and 08/05/2005, which are successively of the order of 1.414, 1.279 and 1.14 m³/s.

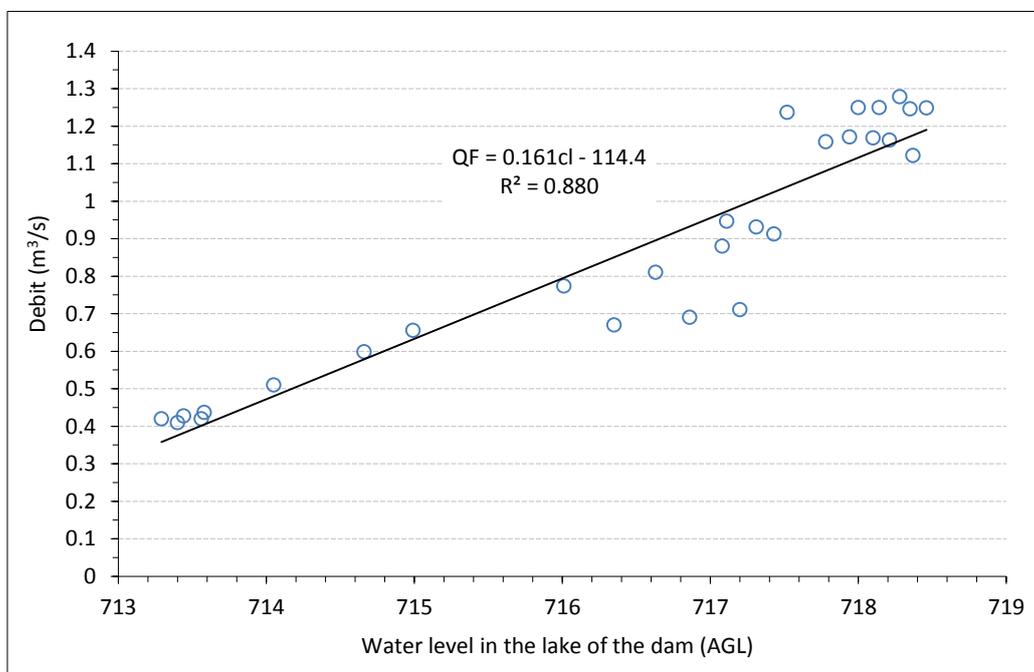
Figure 36. Variation of the leaked flow as a function of the water level for heights less than 718.5 m at Hammam-Grouz dam

The values of the measured leakage rate over time for ratings between 713.5 and 718.5 m are in the range of 0.4 to 1.3 m³/s and vary linearly with the rise of the body of water explaining 88% of the variance. Figure 37 elucidates the change in leak flow as a function of the lake's elevation for ratings between 720.5 and the normal reservoir level.

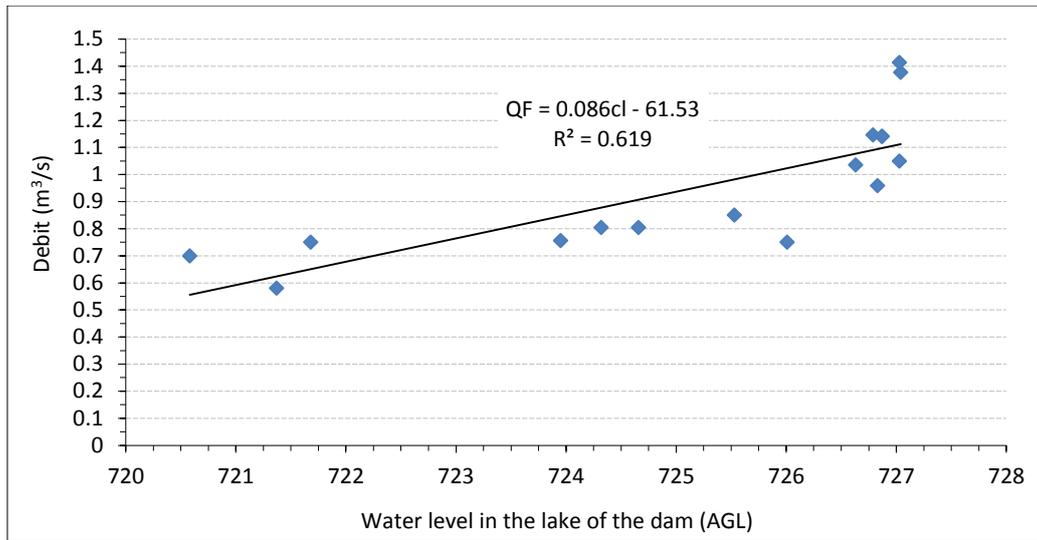
Figure 37. Variation of the leaked flow as a function of water level for heights between 720.5 m and the normal level of the reservoir

The values of the leakage rate measured, over time, for ratings between 720.5 and 727.5 m, are in the range of 0.58 to 1.415 m³/s. However, the decrease in the leakage rate for dimensions greater than 720 m can be explained by the waterproofing work carried out, but for levels close to that of the normal reservoir level (N.R.L), leakage rates, although they have decreased as a result of construction work. They are still important, which can lead to unforeseen situations when there is a rise in the water level. Indeed, the phenomenon of water leaks in the dams has become hazardous if the flow of leaks increases, over time, for the same level of water in the lake.

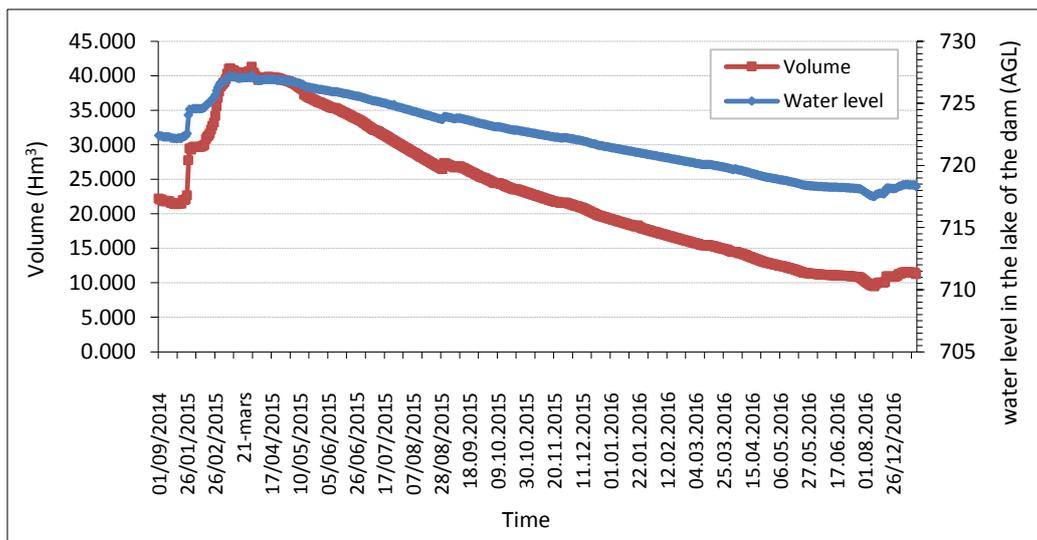
Figure 38. Variation over the time of the couple of water level in the lake and the filling volume at Hammam Grouz dam during the period from 2014 to 2017

The first observation to be learned is that the fall of the couple (water level-stored volume) has become gradual. That is to say, the gradient is less important than that obtained during the appearance of the phenomenon of leaks of water. However, the storage capacity remains below 1/3 of the theoretical one, which proved that the water leaks persisted. Figure 39 illustrates the Variation in the water level at Hammam Grouz dam since its impoundment.

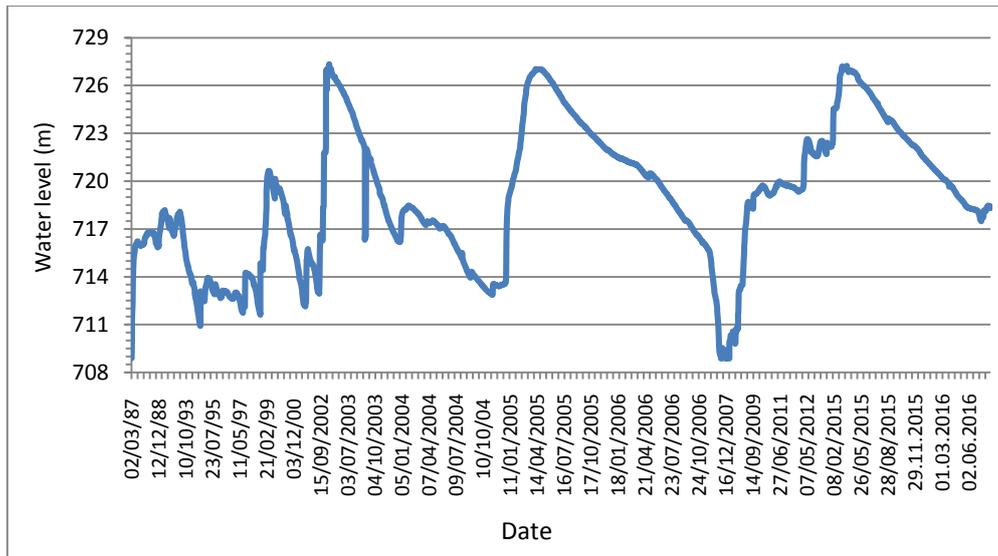
**Figure 39. Variation in the water level at Hammam Grouz dam since its impoundment until the 2016/2017 hydrological year**

The monitoring over time of the level of the water level in the lake shows that the latter, before the first waterproofing work and at each filling, will stabilize at levels below 714 m and after the last works it will be stabilizes at values that do not reach a level of 718 m, which is equivalent to a water volume of less than 15 Hm<sup>3</sup>, while the theoretical capacity is of the order of 45 Hm<sup>3</sup>.

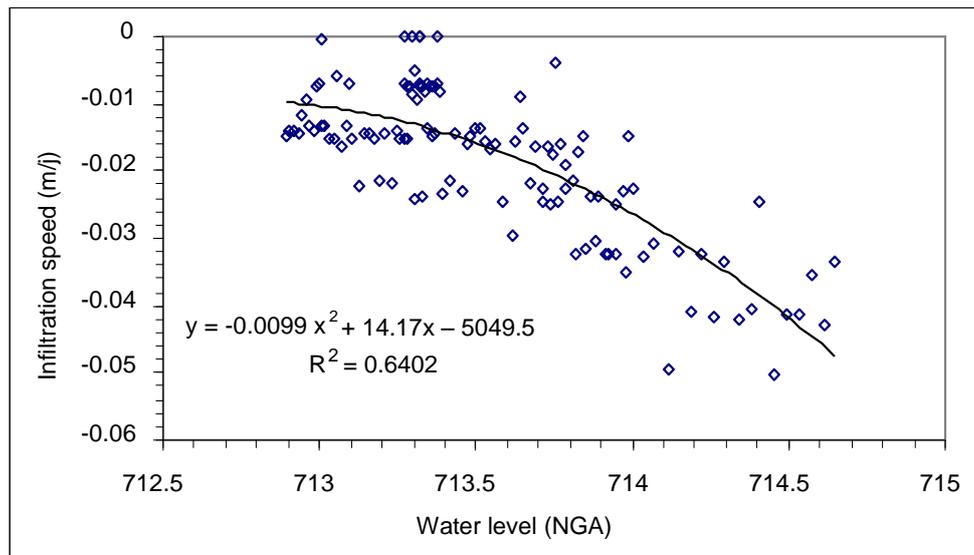
The follow-up of the average permeability coefficient at the beginning of the appearance of the phenomenon of water leaks made it possible to draw Figure 40. Indeed, the average infiltration rate calculated is of the order of 2.069 cm/day for dimensions not exceeding 715 m.

**Figure 40. Variation of the infiltration speed depending on the water level of the lake at Hammam-Grouz dam, Algeria**

Figure 40 illustrates the variation of the infiltration rate as a function of a dimension interval. It emerges that the explained variance does not follow a linear form, which indicates that it will be important for levels close to the spillway.

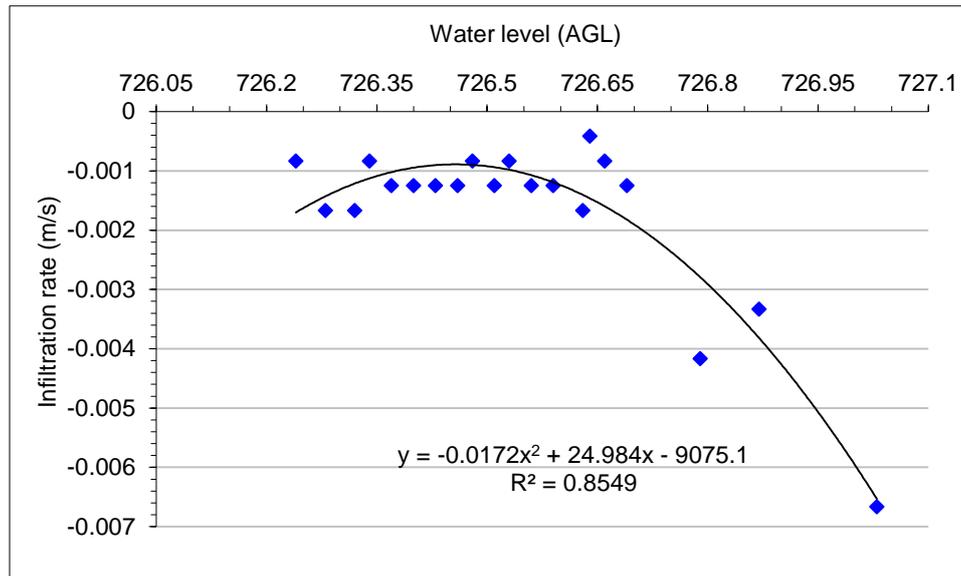
**Figure 41.** Variation of the infiltration speed depending on the water level of the lake at Hammam-Grouz dam, Algeria

This representation indicates that the rate of infiltration increases with the rise of water in the lake.
